## NASA Technical Memorandum 74077

# Evaluation of Three Thermal Protection Systems in a Hypersonic High-Heating-Rate Environment Induced by an Elevon Deflected 30°

Allan H. Taylor, L. Robert Jackson,  
and Irving Weinstein

DECEMBER 1977

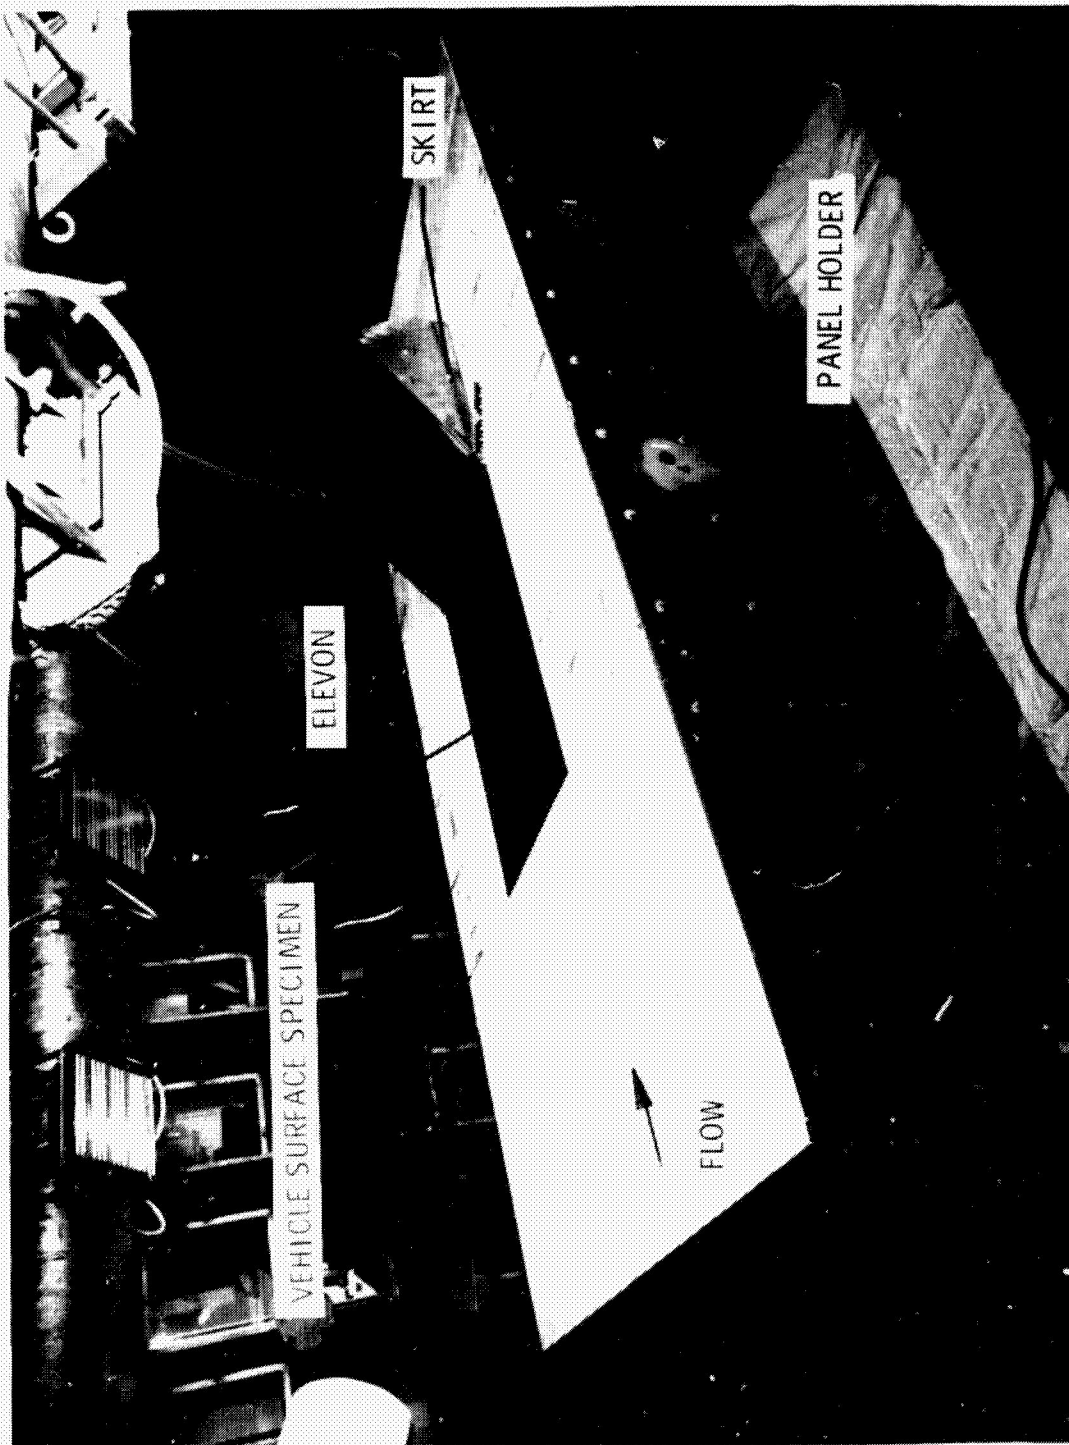
L-76-1441.1

Figure 2.- Panel-holder installation in 8-ft HTST.

The present tests were conducted by using a 147-cm-wide (58-in.), 300-cm-long (118-in.) panel holder shown in figure 2. Its configuration is rectangular with a 20° bevel at the leading edge. A rectangular cutout through the panel holder can accommodate test-panel sizes up to 108.0 by 152.4 cm (42.5 by 60.0 in.) with access to the back of the test panel by means of a removable plate on the back surface of the panel holder. The panel holder is protected by 2.54-cm-thick (1-in.) Glasrock foam tiles which were bonded to the substructure. Uniform turbulent flow over the panel holder is assured by trips located on the surface approximately 12.7 cm (5 in.) aft of the leading edge (ref. 3).

A 50.8-cm-wide (20-in.) by 134.6-cm-long (53-in.) cutout was provided in the surface of the panel holder to install test specimens as shown in figure 2. The forward end of the cutout received the simulated vehicle surface panel, and the aft end received the simulated elevon assembly.

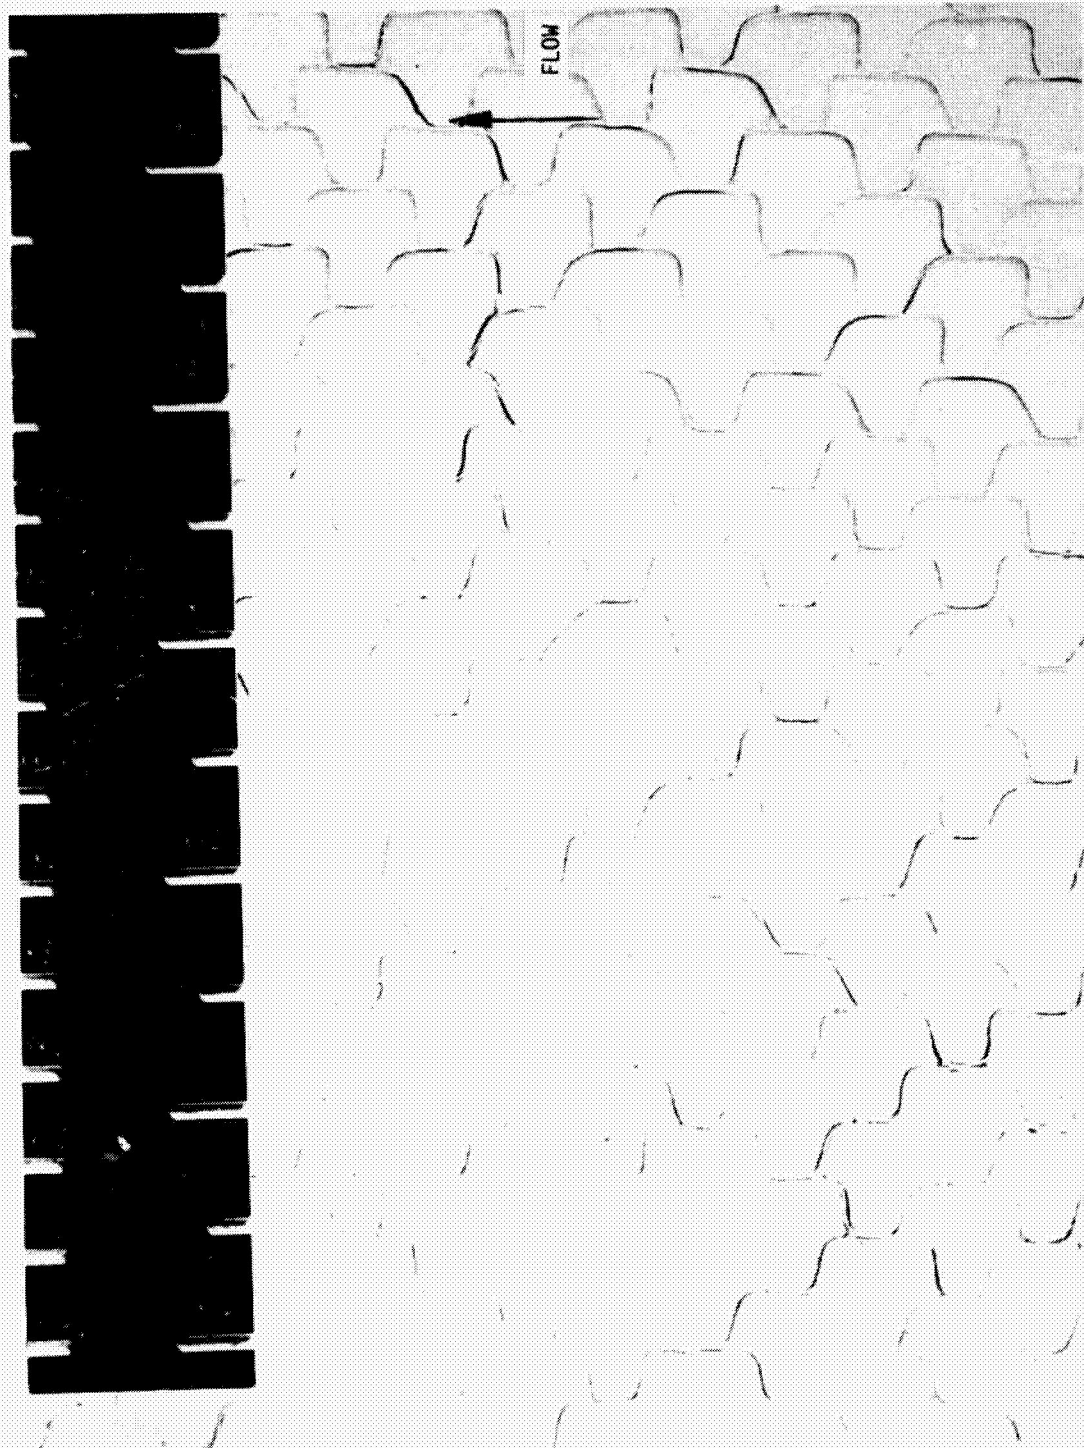
L-76-1708.1

Figure 8.- Shrinkage of the honeycomb-filled insulator-ablator cells.

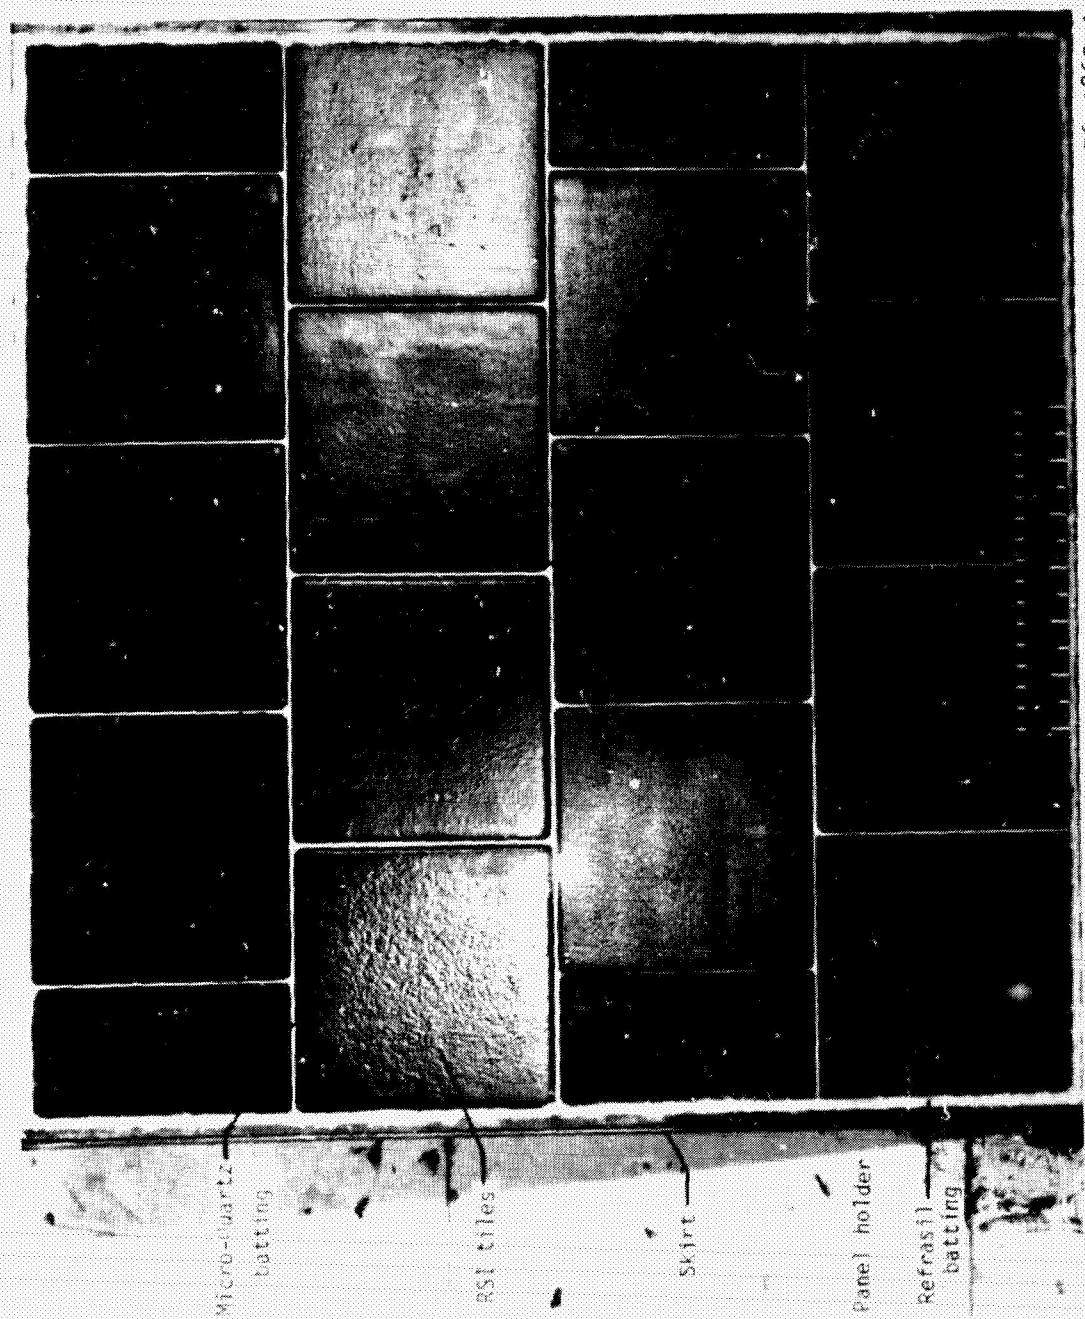
L-76-1863.1

Figure 10.- The RSI specimen installed in panel holder.
